Healthy Here

Baseline Walkability Evaluation Report

May 2016

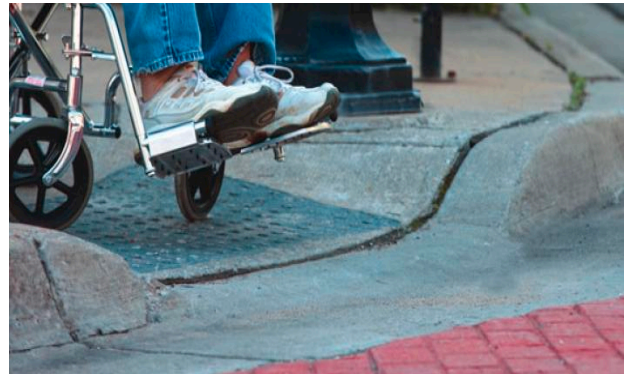
- Long distances between road crossings and inconsistent size of city blocks
- High volume traffic with wide lanes that encourage high speeds
- Steep, frequent curb cuts (i.e., cuts into curbs to allow vehicle access or pedestrian crossing; see photo)
- Uneven surfaces on walking paths and sidewalks
- Commercial spaces that are car focused rather than oriented for pedestrian and bicycle access
- Poor lighting, landscaping, and shade
- Actual and perceived crime, which discourages active transportation and physical activity in the area because of fear for one's safety

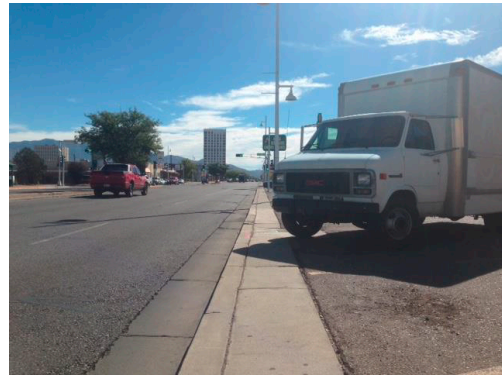
The SM intersection received an overall rating of 60.6%, with the lowest value (1) assigned to SM 3 because the path decreases to less than 2 feet wide between Madison Street and Monroe Street (minor arterials) (Figure 2). The path is too narrow and nearly impassable for wheelchairs because of a lack of curb cuts (Figure 3).

Figure 2. *Narrow sidewalk in SM 3.*

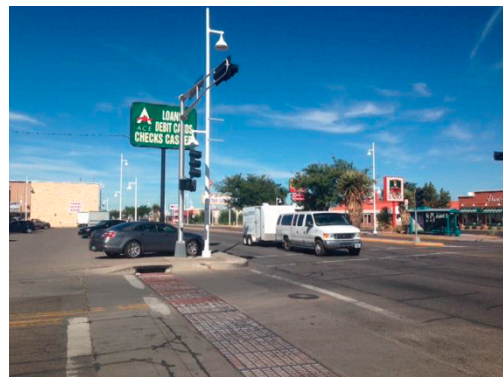
Figure 3. *Lack of curb cuts and faded crosswalk in SM3.*

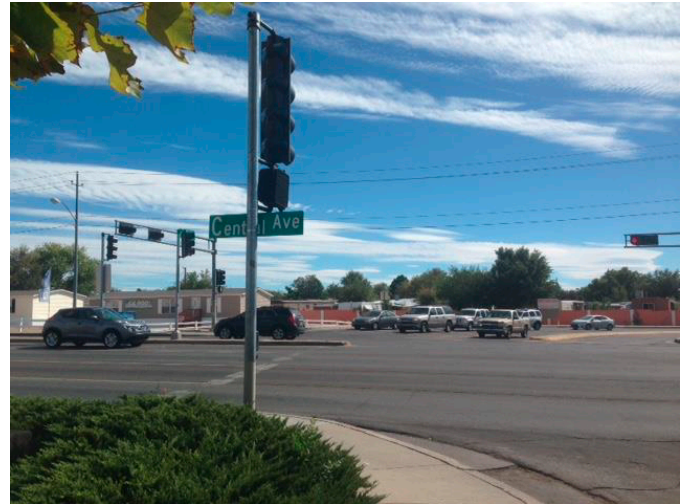
Figure 5. Lack of a marked sidewalk at CZ intersection.

barriers to passage at the sharp curve near the intersection, forcing pedestrians into traffic. The east side of the CZ intersection has no crosswalk (Figure 5). It also has poor wheelchair access, maintenance issues, poor aesthetics, and very little shade.

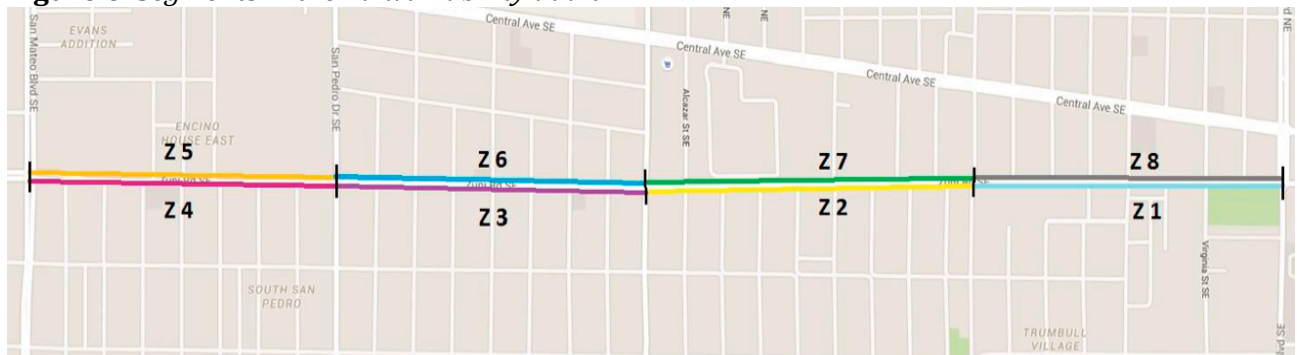
Figure 6. Segments in the Zu walkability audit.

The Zu walkability audit included eight segments: from San Mateo Boulevard to San Pedro Drive (Z 4 and 5), San Pedro Drive to Louisiana Boulevard (Z 3 and 6), Louisiana Boulevard to Pennsylvania Boulevard (Z 2 and 7), and Pennsylvania Boulevard to Wyoming Boulevard (Z 1 and 8) (Figure 6).

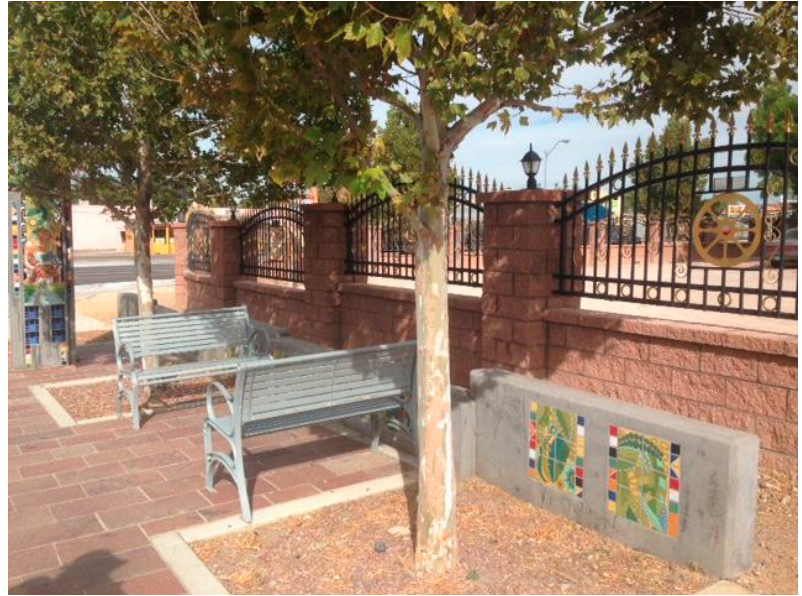
This section received an overall percentage score of 60.8%. Higher values were associated with segments that included many bus stops with shelters and public art in Z 7 (Figure 7). Z 2 received a score of 5 for crosswalks because there are four traffic-calming devices at the minor arterial roads.

Figure 7. *Shaded area with benches, public art, and landscaping in Z 7.*

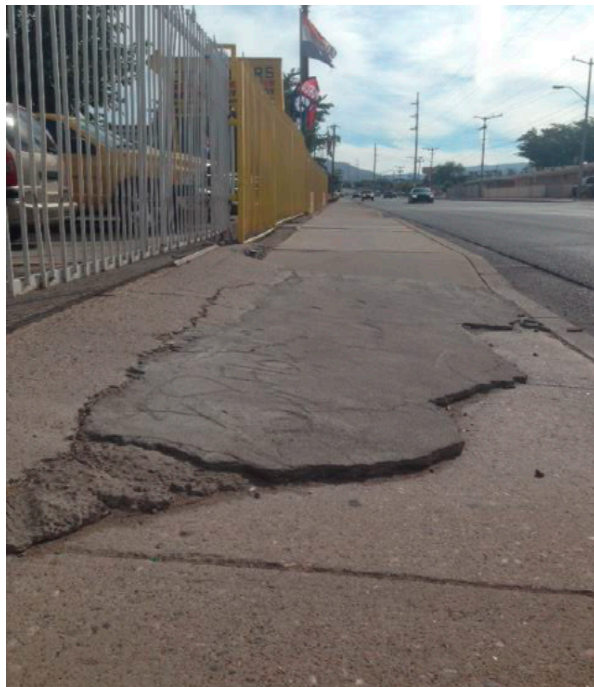
Figure 8. *Poorly maintained sidewalk in Z 8.*

In Z 8, the University of New Mexico's Southeast Heights Clinic has a notable buffer and pleasant landscaping. Lower segment scores were associated with high-volume driveways and poorly maintained sidewalks (Figure 8) that present tripping hazards for pedestrians and make it difficult for wheelchairs to pass.

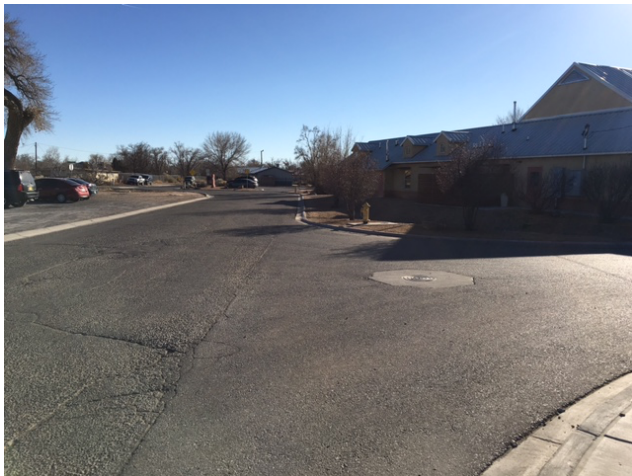
The south entrance to the SVHC parking lot also presents difficulties for pedestrians. There are no sidewalks on either side of the road, forcing pedestrians to walk in the street. A parking area on the east side empties directly into the road (without crossing a sidewalk), increasing the possibility for pedestrian conflicts (Figure 10). Walking on the west side of the street is also unsafe. The intersection at El Centro Familiar Boulevard and Citation Drive is unmarked, and there is no stop sign for vehicles traveling from El Centro Familiar Boulevard to Citation Drive. Visibility is limited by the building on the southwest corner of the intersection (Figure 10). The sidewalk leading out of the SVHC parking lot places pedestrians on the west side of the road, into the intersection of El Centro Familiar Boulevard and Citation Drive (Figure 11).

Figure 10. *El Centro Familiar Blvd at Citation Dr. Walking on either side of the road (HC 3 & HC 4) places pedestrians at risk for conflict.*

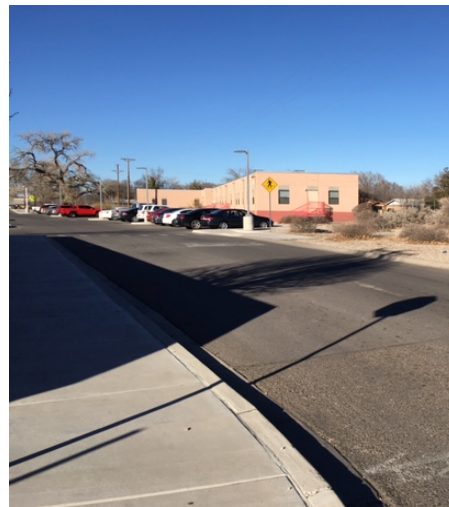
Figure 11. *Citation Dr at the entrance to the SVHC. The sidewalk on the west side of the street directs pedestrians into the path of traffic coming from El Centro Familiar. The east side of the road has no sidewalk (HC 3 & HC 4).*

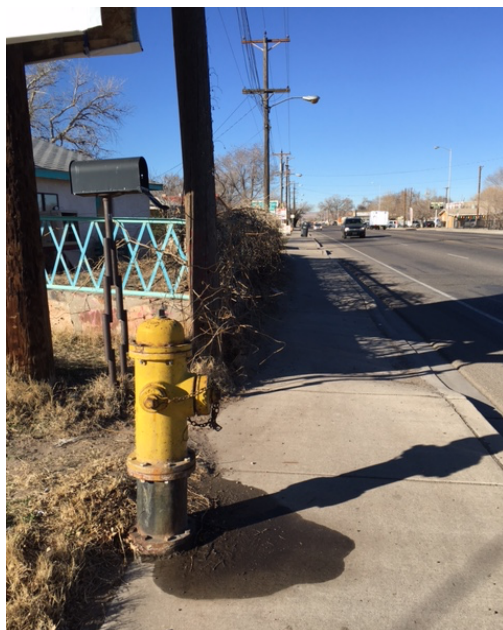
Figure 13. Bridge Boulevard's unused curb cuts and deteriorating infrastructure lowered its scores (B 8).

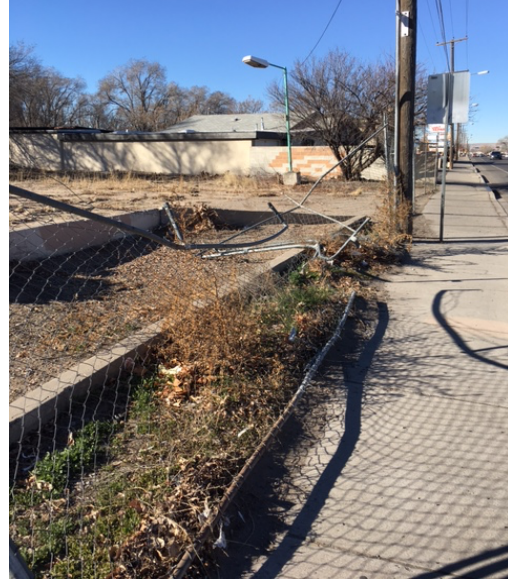
Bridge Boulevard also has a large number of abandoned buildings, vacant lots, and deteriorating infrastructure features (Figure 14). The sidewalk is cracked and buckled in many places, which could restrict access for people using wheelchairs. Evaluators saw a person using a motorized wheelchair in the bicycle lane.

Figure 14. *The presence of abandoned buildings and empty lots decrease Bridge Boulevard’s walkability (B 8).*

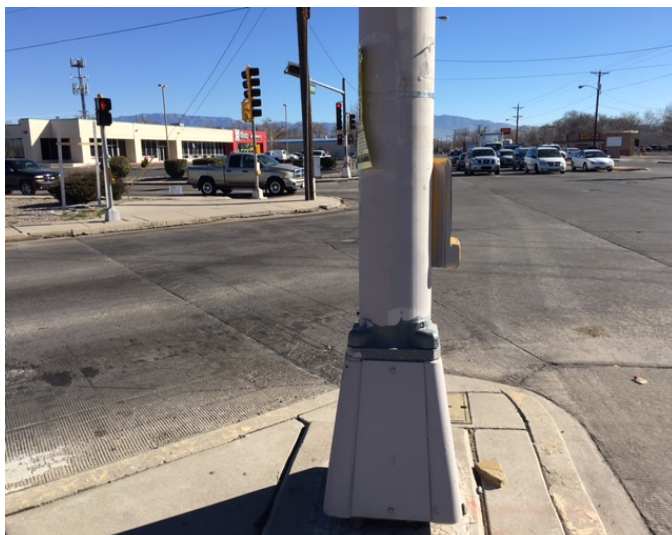
At the time of the assessment, the crossing lights at the Five Points Road intersection were not functioning. The buttons for those lights are placed far from curb cuts (where curb cuts existed) and positioned so that users are forced into a very small area of sidewalk between the post and the road. Accessing the buttons would be difficult for a person using a wheelchair (Figure 15).

Crosswalks are very faded and curb cuts into crosswalks are inconsistently placed (i.e., not aligned with crosswalks). As a result, all sections of road at this intersection received low scores. Streets connected at the Bridge Boulevard/Five Points Road intersection (Sunset Road and Five Points Road) had low scores because of a lack of shade, buckled sidewalks or a sidewalk on only one side of the street, and business entrances that increased the risk of pedestrian conflicts.

Figure 15. *Difficult-to-reach buttons, faded crosswalks, and a non-working signal lowered scores for all segments connected to the Five Points Road intersection (B1–B6 and B9 & 10).*

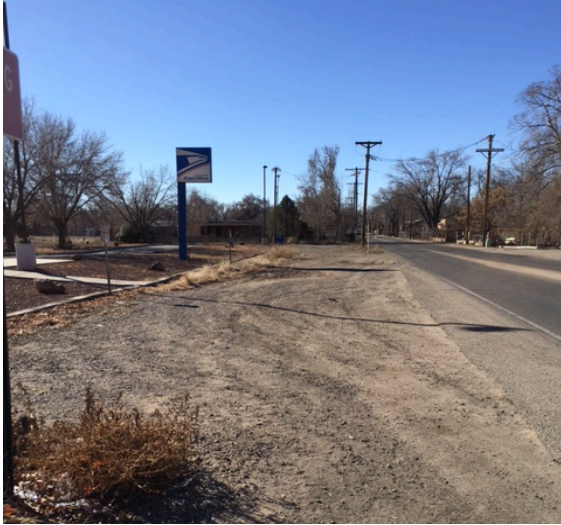
Figure 16. Area in front of the Sunset Road post office.

Sections B 5 and B 6, on Sunset Road north of Bridge Boulevard, received low scores because of the potential for pedestrian conflicts at the Five Points Road intersection, the lack of a sidewalk on one side of the road, and a large number of business driveways. Segments B 9 and B 10 along Sunset Road south of Bridge Boulevard have no sidewalks on either side of the street. On the east side, a busy post office has driveways without stop signs for exiting traffic. There is a large dirt area between the post office grounds and the street that could be developed into a pedestrian-friendly walking space that is buffered from the road (Figure 16).
